NATIONAL ADVISORY COMMITTEE FOR AERONAUTICS

WARTIME REPORT

MEASUREMENTS IN FLIGHT OF THE STABILITY, LATERAL-
CONTROL, AND STALLING CHARACTERISTICS OF AN AIRPLANE
EQUIPPED WITH FULL-SPAN ZAP FLAPS AND
SPOILER-TYPE AILERONS

MEMORANDUM REPORT

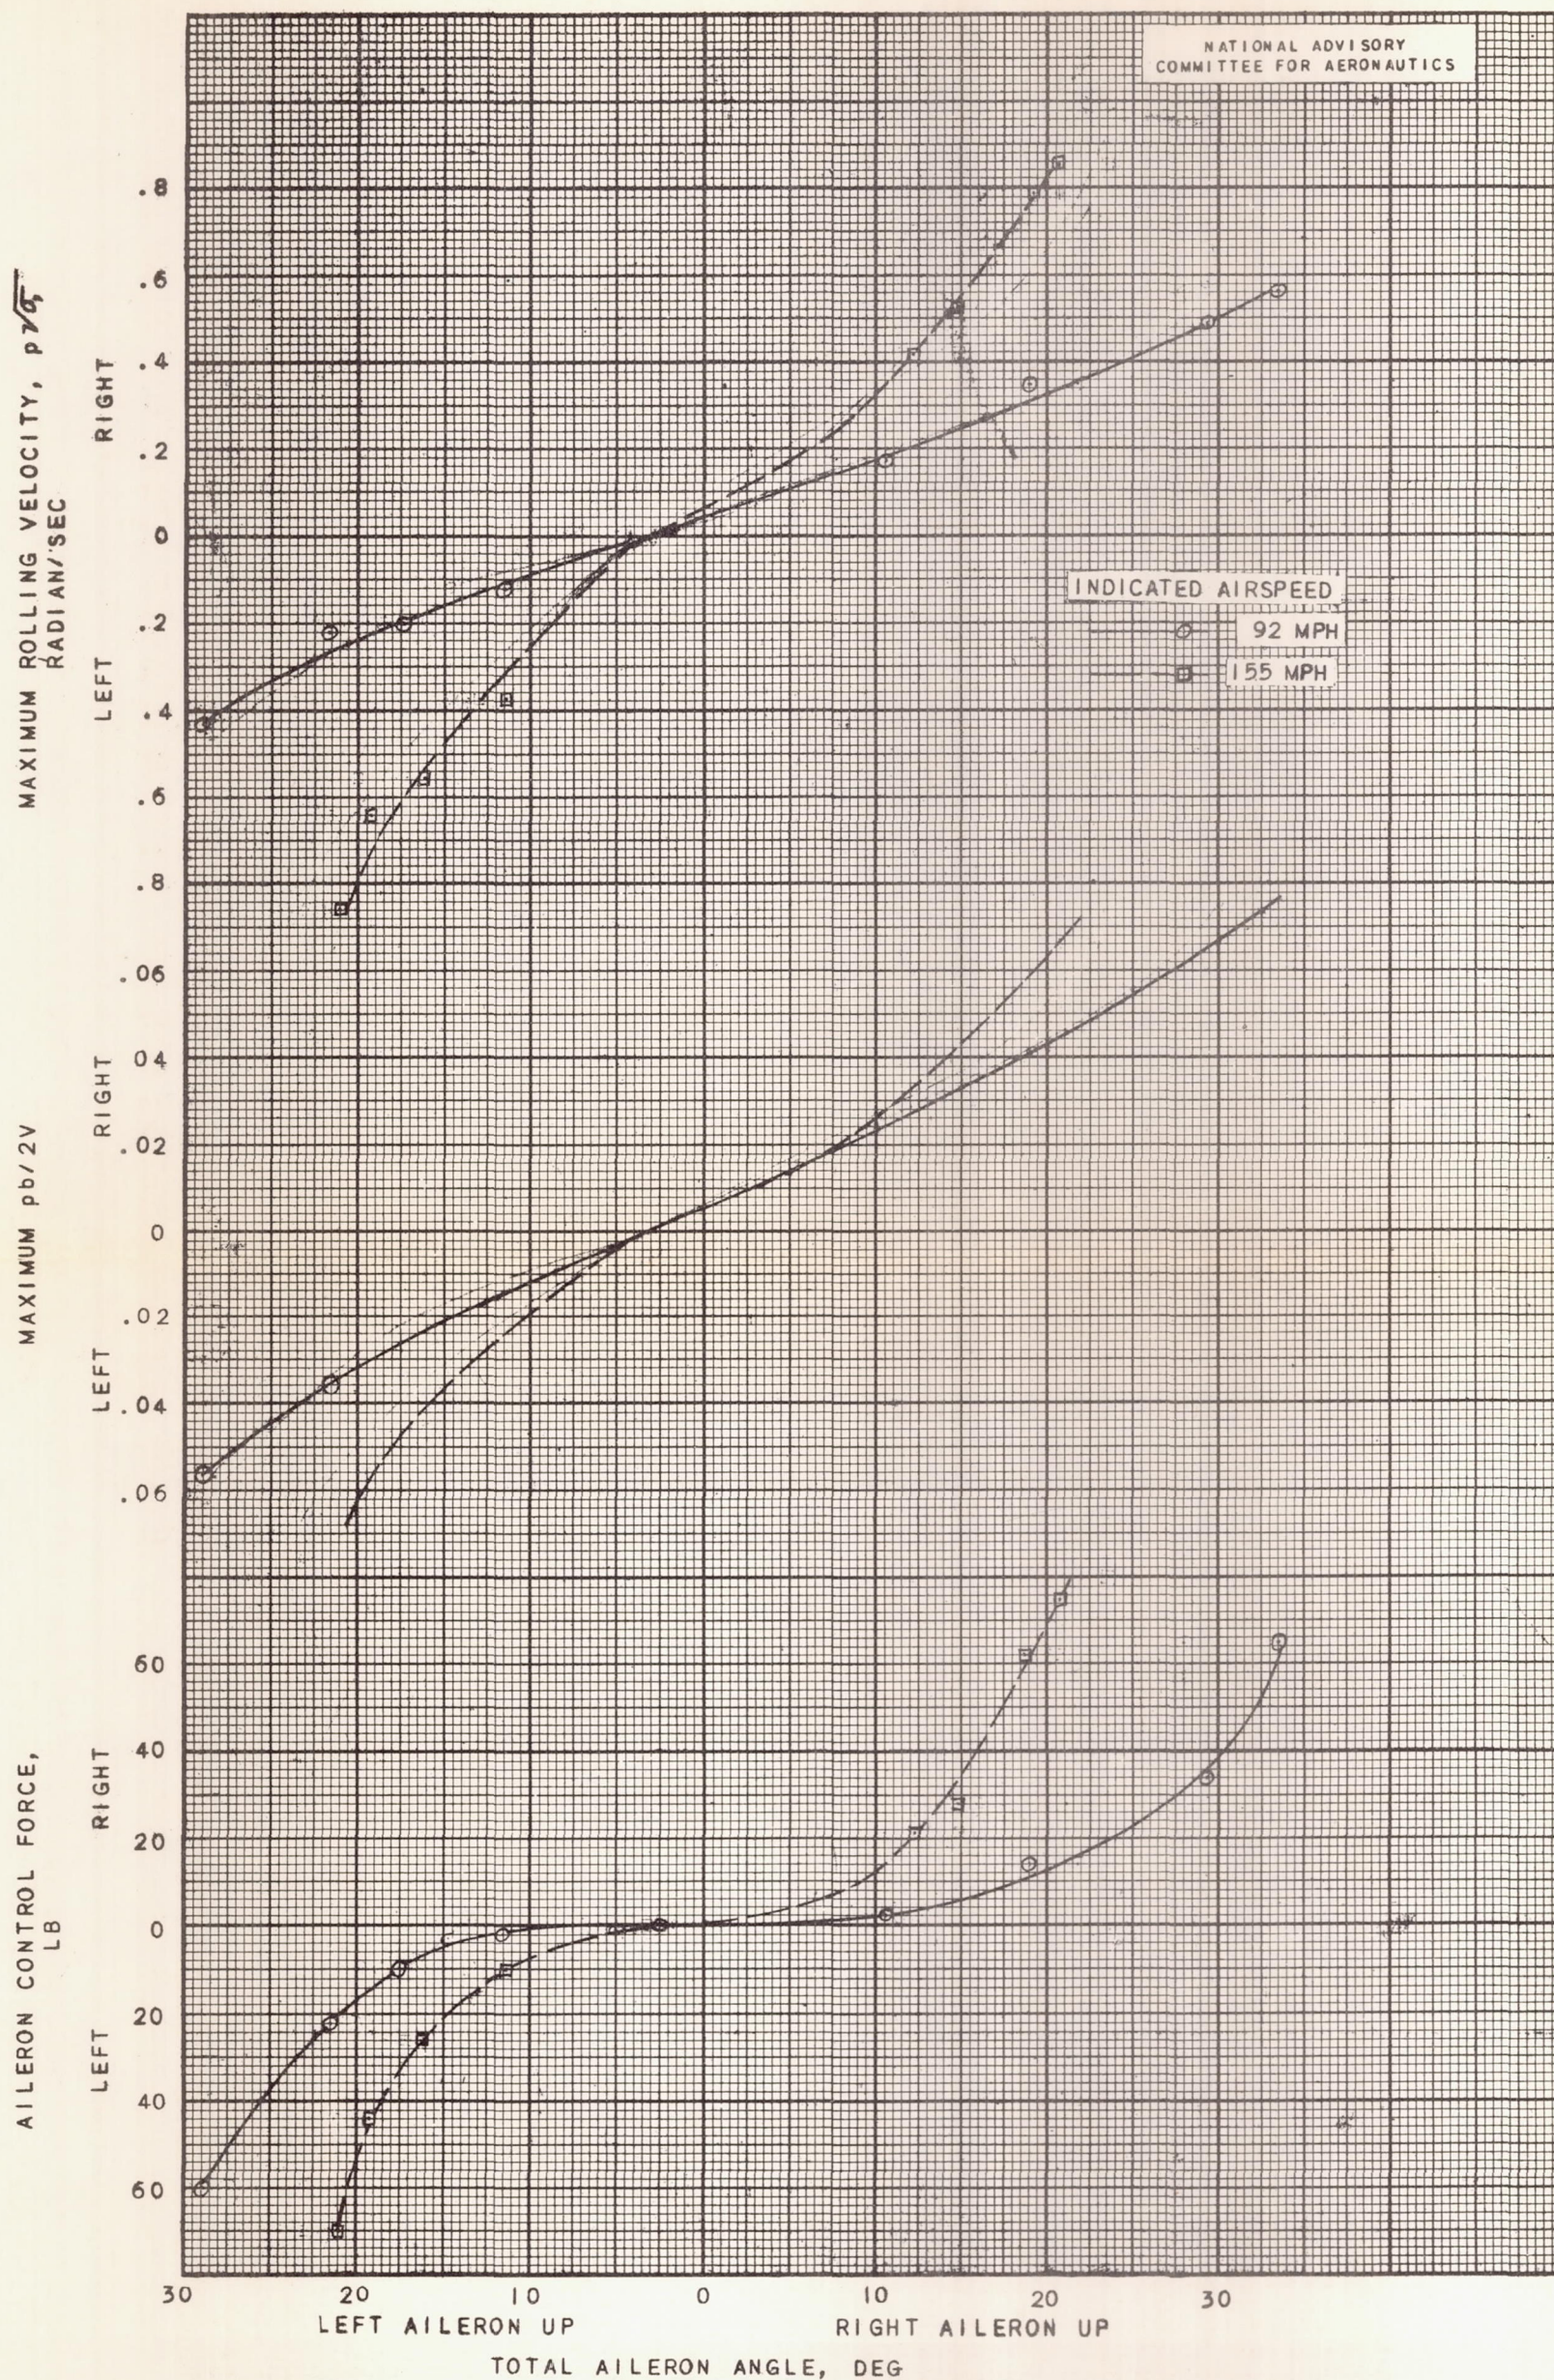
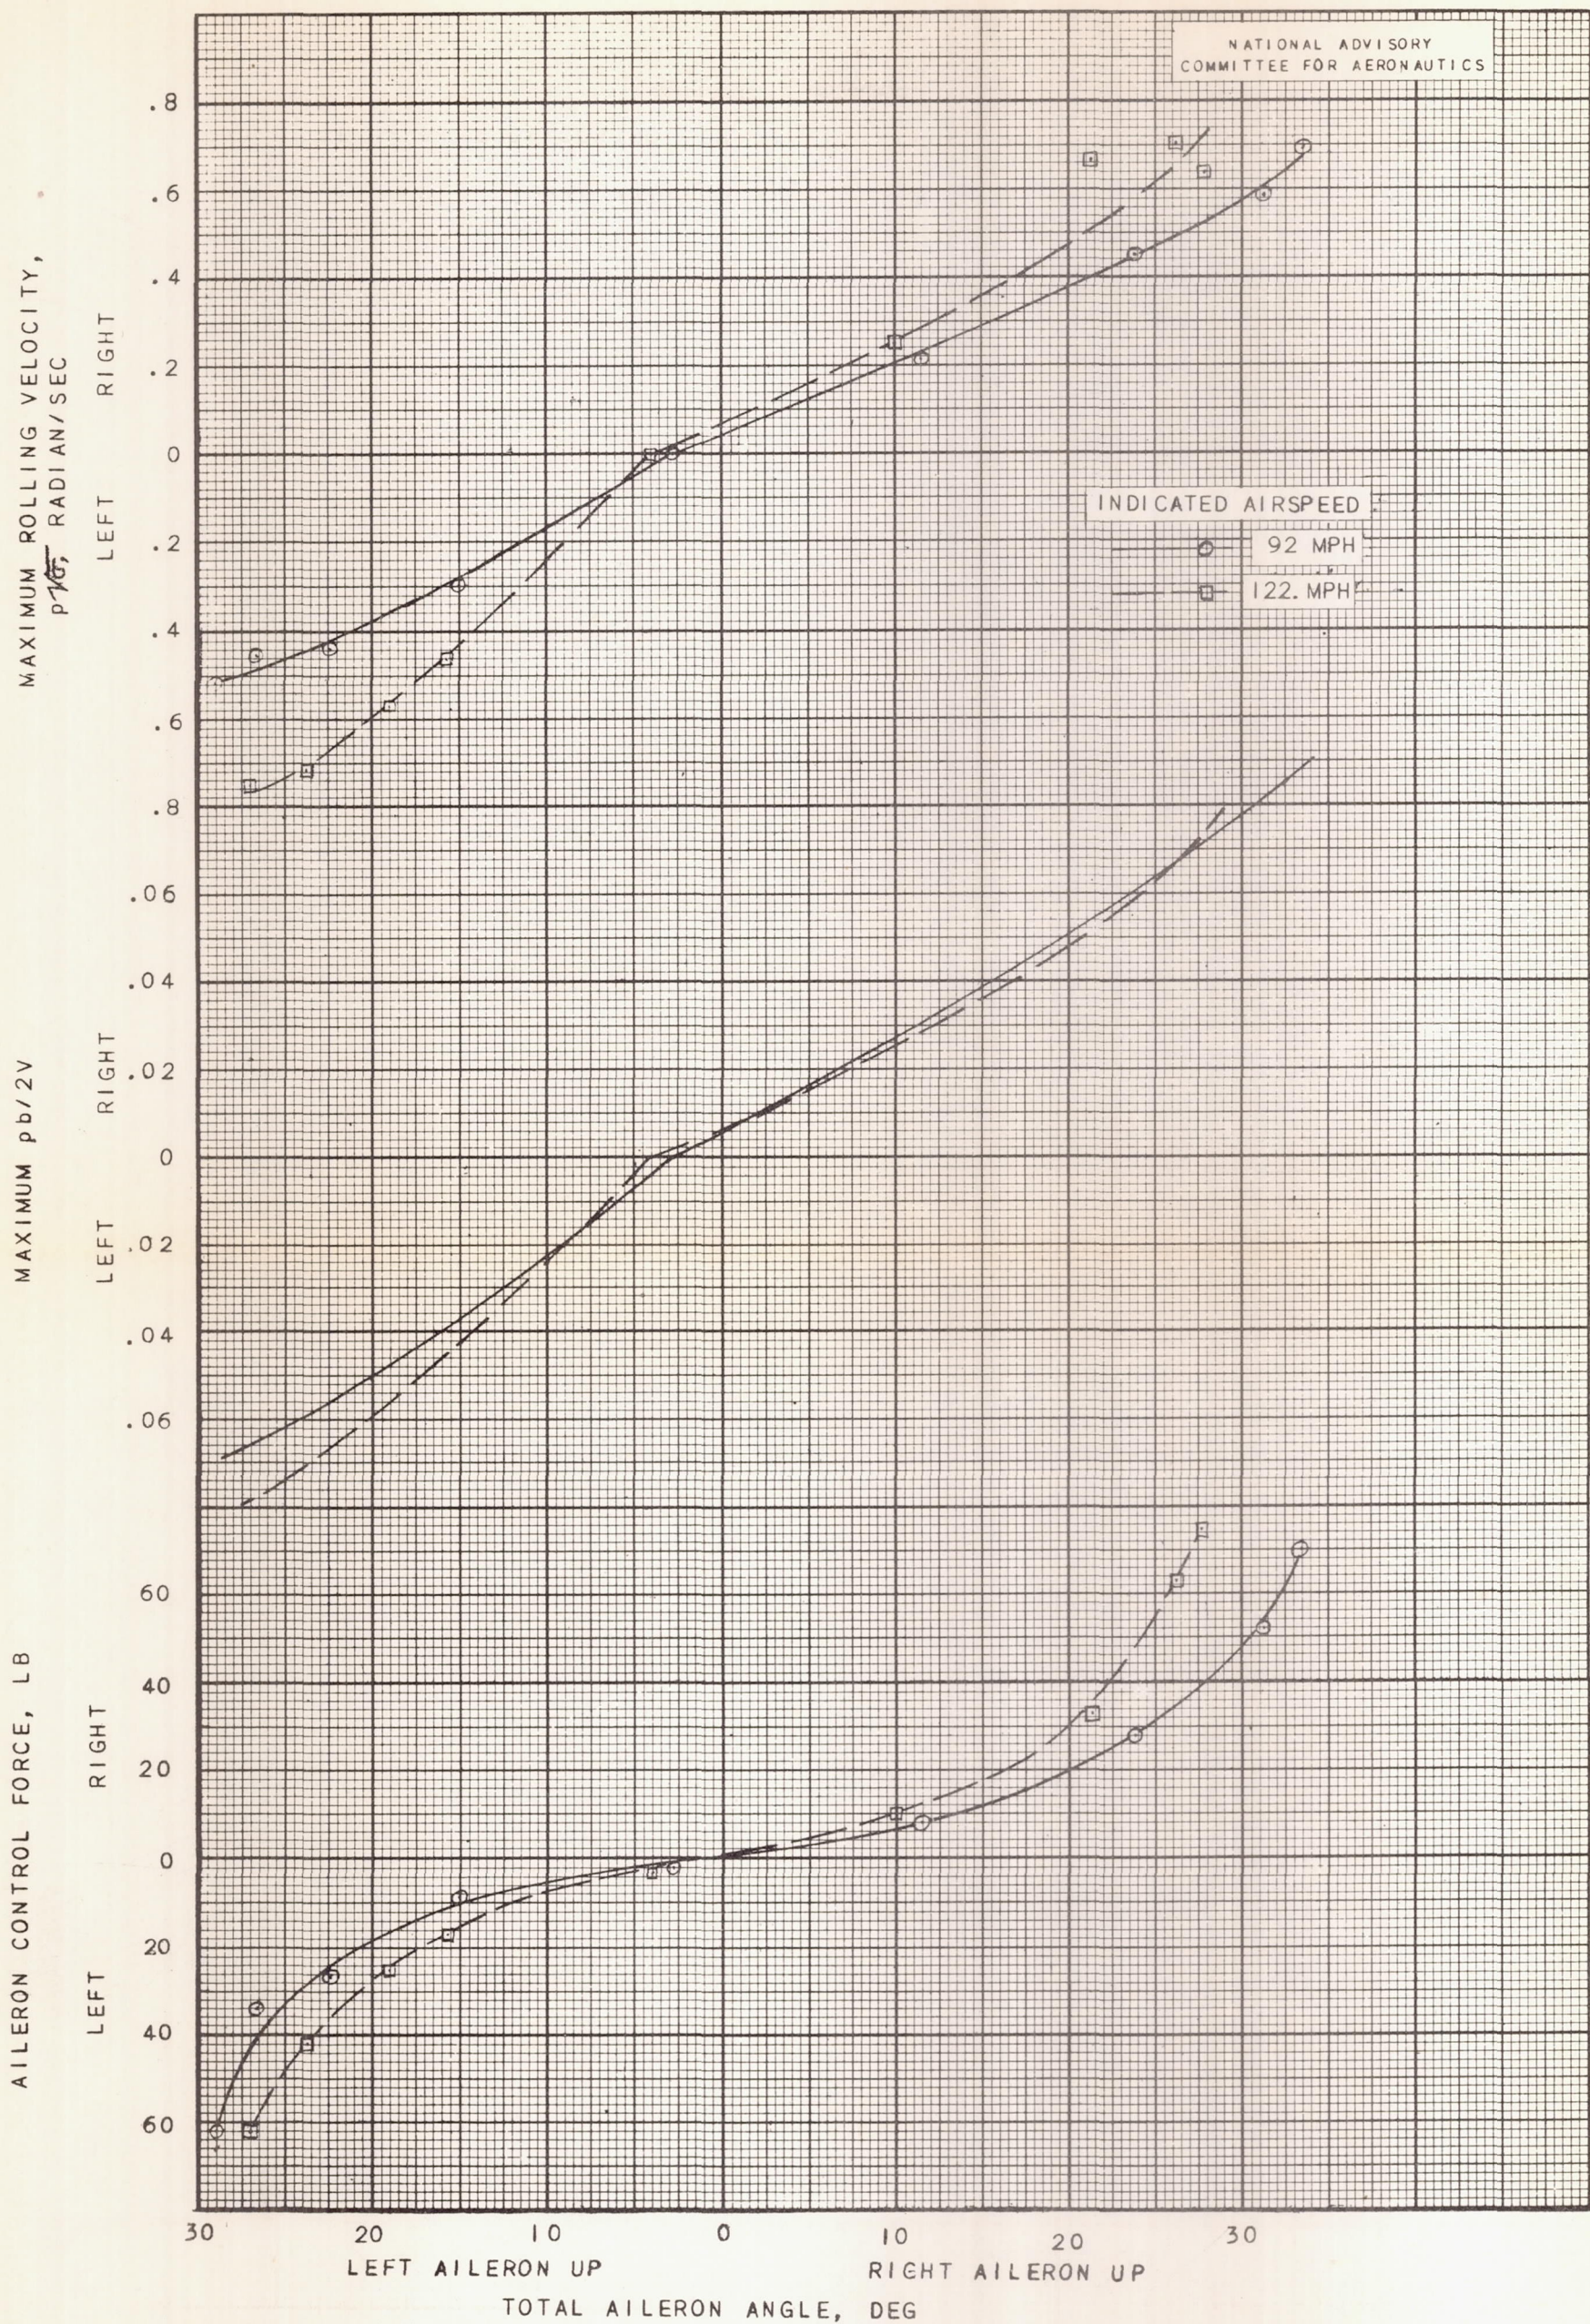
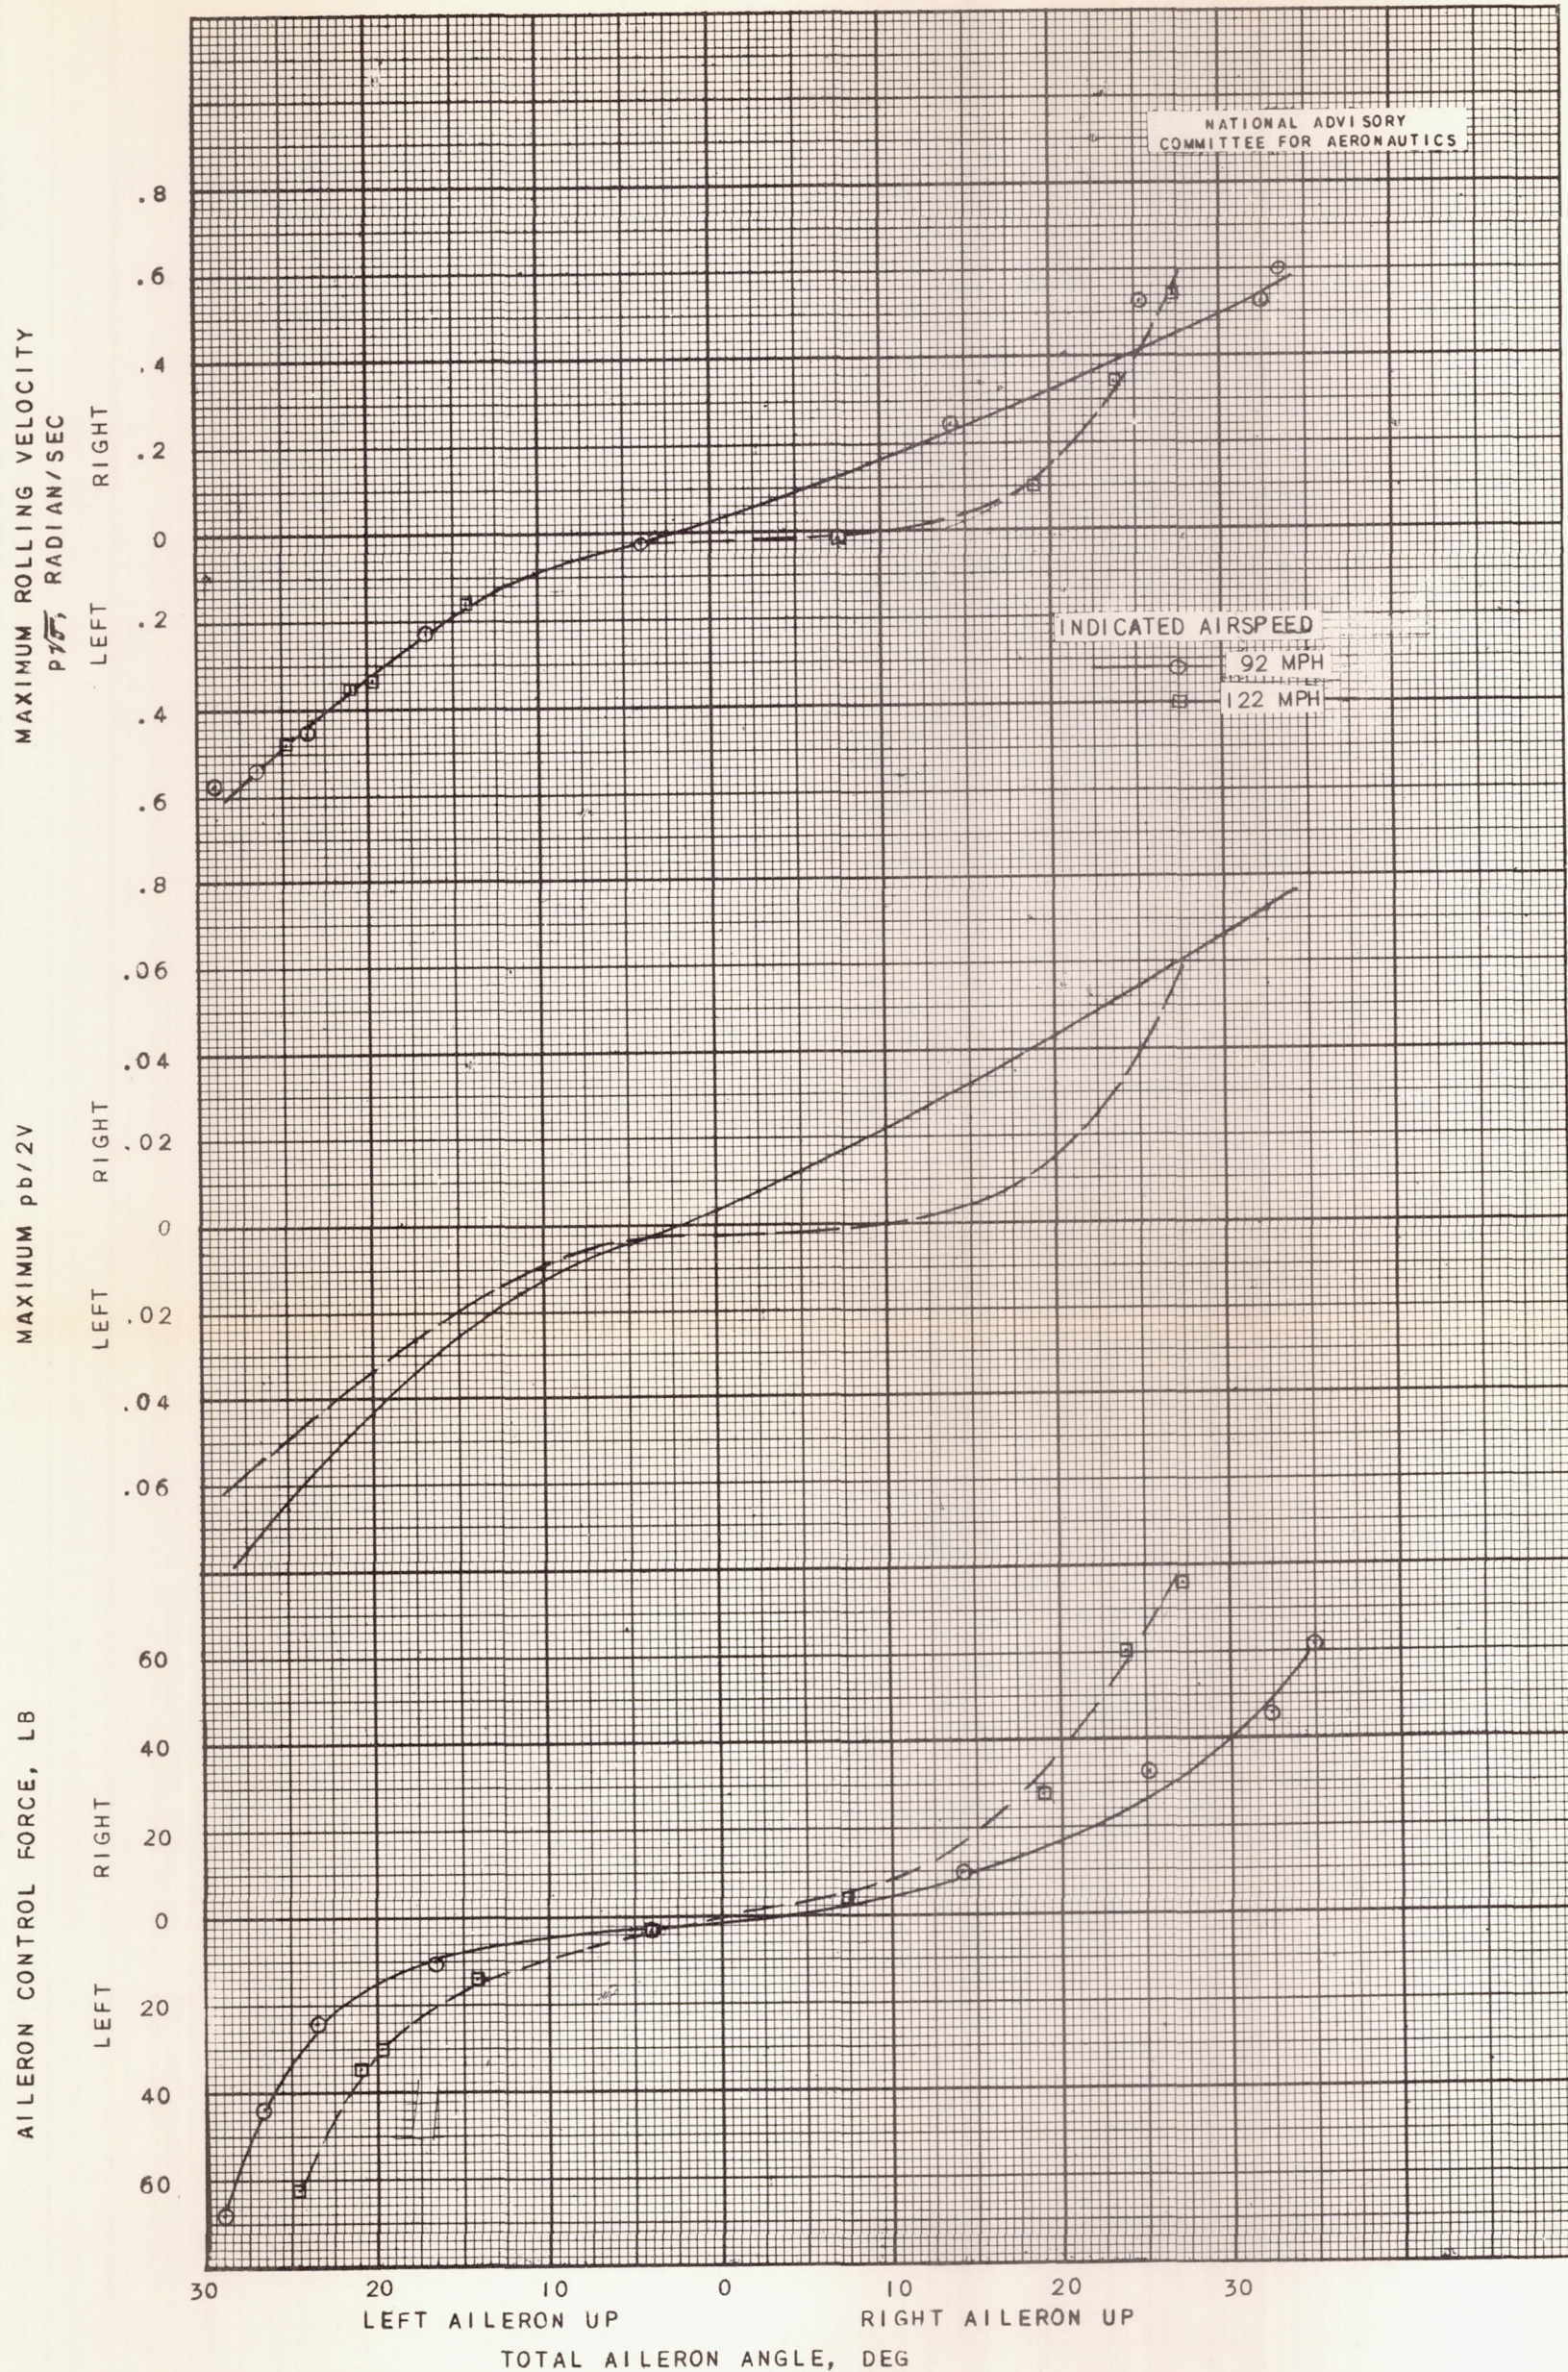
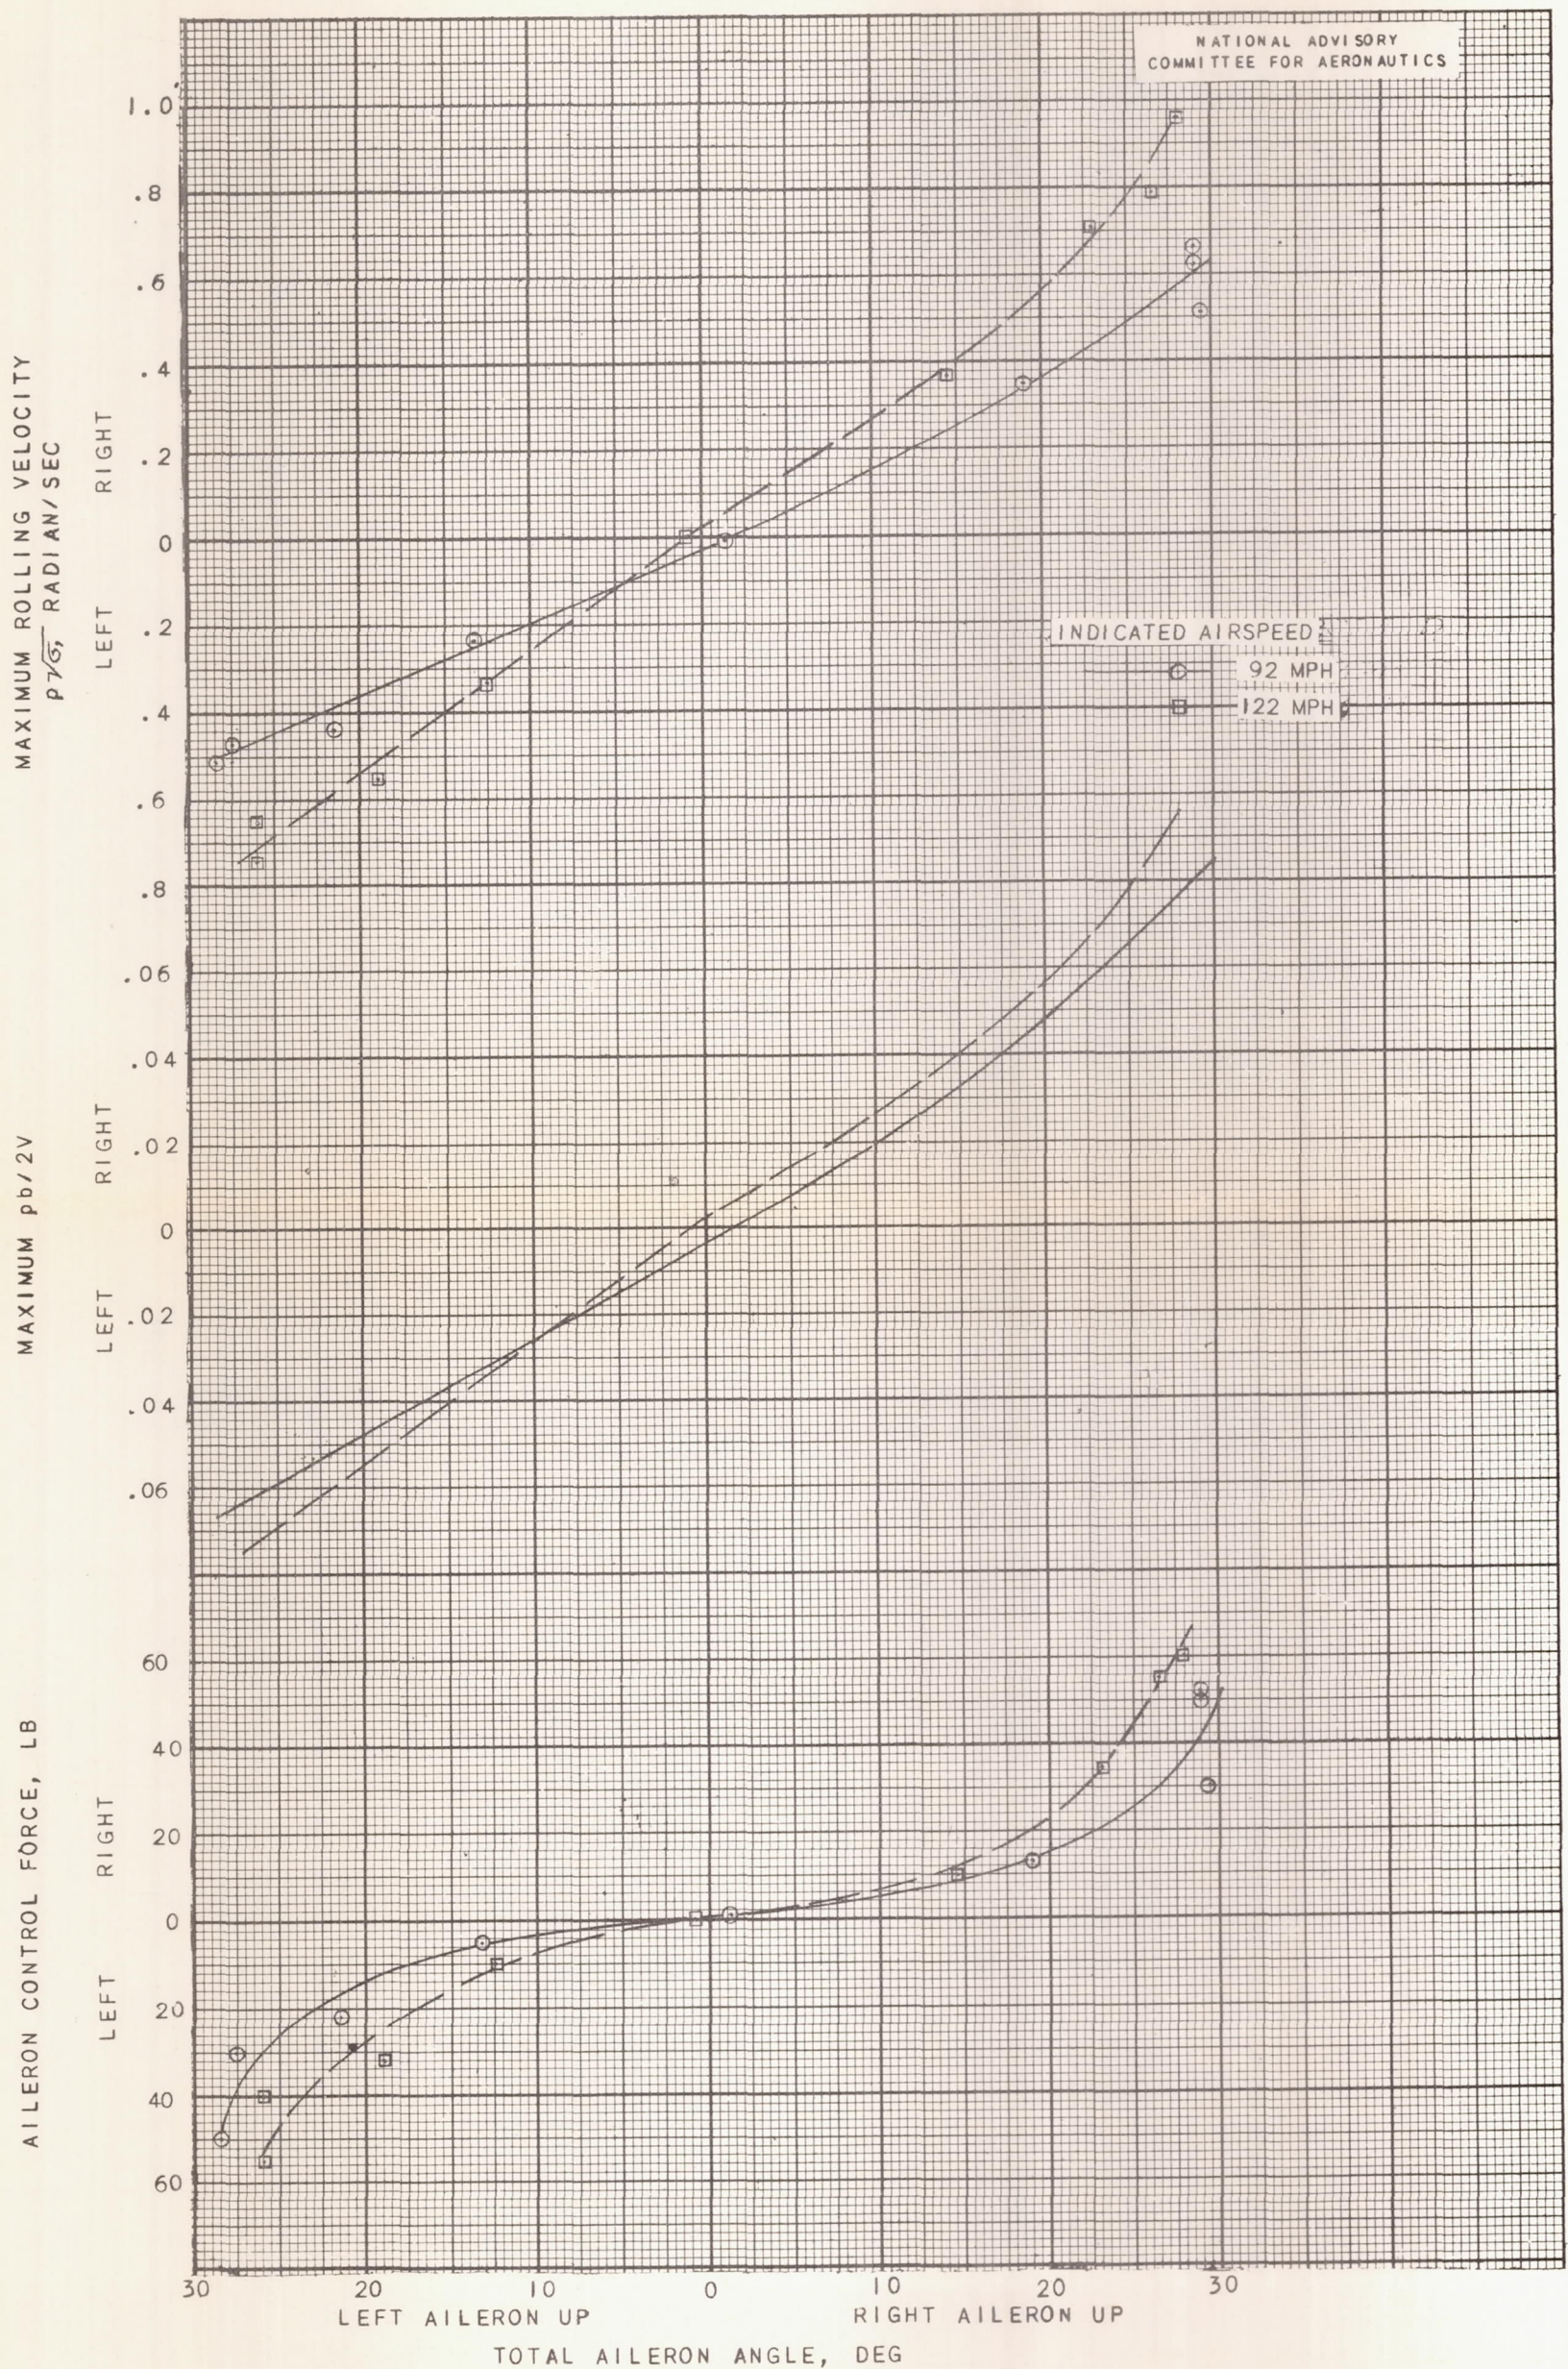
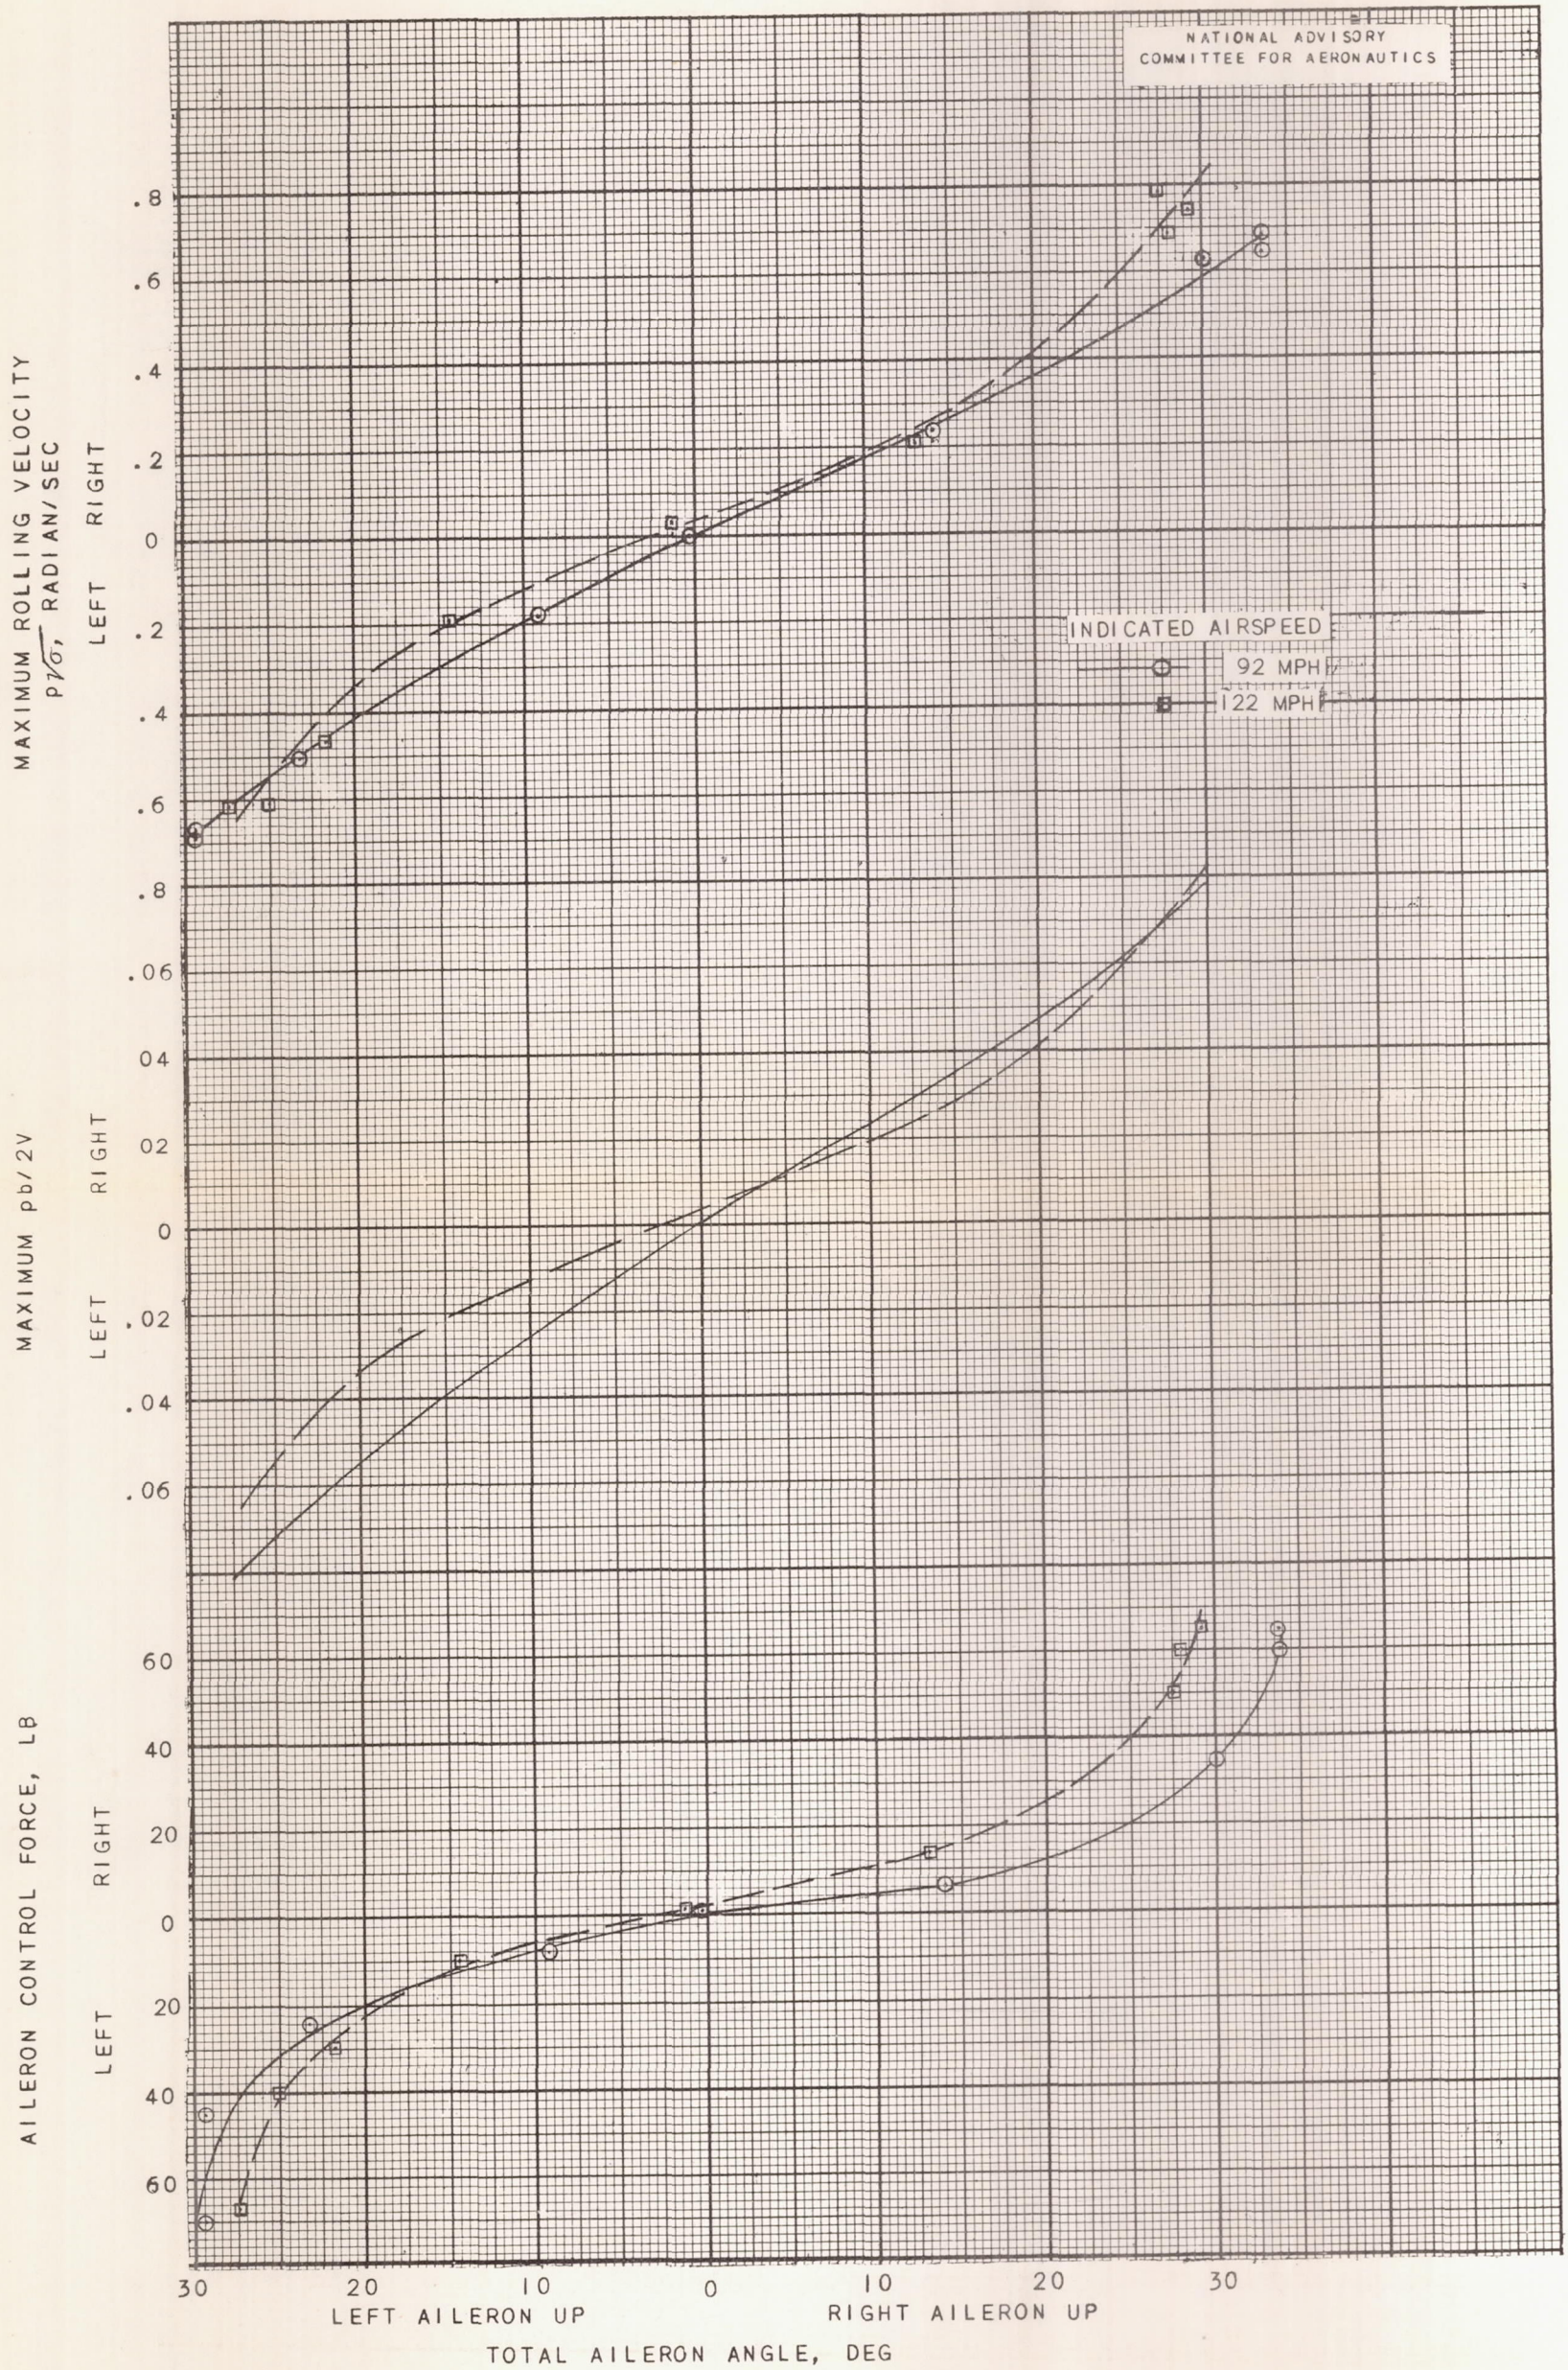
FIGURE 30. - AILERON CONTROL CHARACTERISTICS, RATED POWER, FLAPS UP.

FIGURE 31. - AILERON CONTROL CHARACTERISTICS, RATED POWER, FLAPS ONE-HALF DOWN.

FIGURE 32. - AILERON CONTROL CHARACTERISTICS, RATED POWER, FLAPS DOWN.

FIGURE 34. - AILERON CONTROL CHARACTERISTICS, POWER OFF, FLAPS ONE-HALF DOWN.

FIGURE 35. - AILERON CONTROL CHARACTERISTICS, POWER OFF, FLAPS DOWN.

Aileron control characteristics.— The variation of maximum rolling velocity, maximum $pb/2V$ (the tangent of the helix angle generated by the wing tips), and aileron control force with total aileron angle corrected for stretch in the system is shown in figures 30 to 35 with the ailerons in their original condition. It may be seen that the maximum rolling velocity varied smoothly with, and was approximately proportional to, the aileron angle for all conditions investigated except in the rated-power, flaps-down condition at 122 miles per hour. The rolling acceleration, in every case, attained its maximum value within 0.2 second after the controls had reached their given deflection and was always in the correct direction, thus satisfying the requirement of references 3 and 4. The rolling criterion, expressed by the maximum value of $pb/2V$ resulting from an aileron control force of 30 pounds (figs. 30 to 35), is tabulated below for each flight condition.

It is observed that in only two conditions (power off, flaps one-half and full down at 92 mph) did the above values reach the minimum of 0.07 recommended by the requirement of references 3 and 4. The flap position seemed to have no marked effect on the rolling criterion; the optimum position, however, appears to be one-half deflection. No consistent difference exists between the values in right rolls and those in left rolls.

The variation of the aileron control force with aileron angle, as shown in figures 30 to 35, for all flight conditions is a smooth curve having a flat portion on either side near neutral position. The combined effects of this force characteristic and the high friction force in the control system tend to produce poor self-centering characteristics and insufficient control feel, which is objectionable from a pilot's standpoint.
